11. TITLE (Include Security Classification) <b>Repair of Dam Intake Structures and Conduits: Case Histories</b>					
12. PERSONAL AUTHOR(S) <b>Campbell, Roy L., Sr., and Bean, Dennis L.</b>					
13a. TYPE OF REPORT <b>Final report</b>		13b. TIME COVERED FROM _____ TO _____		14. DATE OF REPORT (Year, Month, Day) <b>January 1988</b>

19. ABSTRACT (Continue on reverse if necessary and identify by block number)					
<p>Based on a survey of inspection reports, 29 percent of the maintenance and repair problems at Corps dams were observed in intake structures and conduits. Repairs to these structures did not perform as desired in better than 40 percent of the reported efforts and with better than 21 percent reported as failed. A number of products whose manufacturer's literature indicated that their products were suited for application in a wet environment such as that found in intake structures and conduits failed. In some instances, the repair technique was at fault. In others, the product failed to perform as indicated.</p> <p>This report documents selected repair efforts to intake structures and conduits and presents them in a case history format that includes a project description an

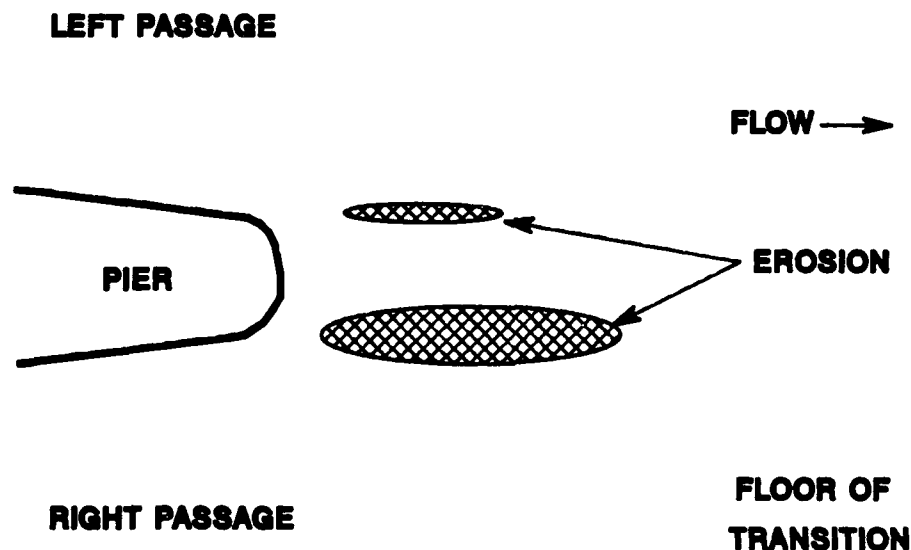
Figure 28. Sketch of abrasion damage in floor of transition, Cave Run Dam, 1982

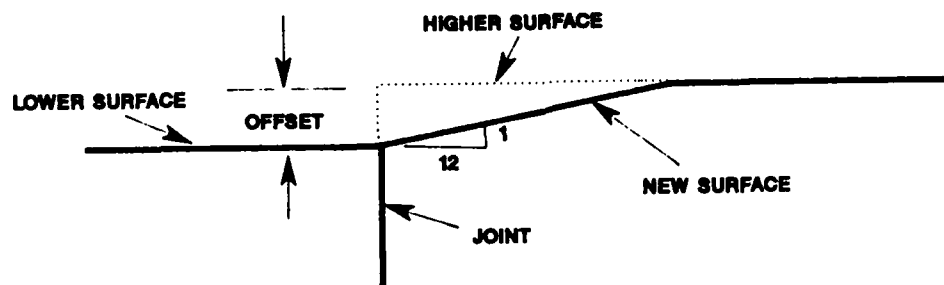
Figure 35. Sketch of repair of offset, Hidden Lake Dam

127. In 1984, district personnel rented a high-speed, car buffer type grinder with a diamond stone. The higher surface at each of the two joints was ground to the level of the lower surface at the joint and cut back on a 1 to 12 slope away from the joint (Figure 35). This produced a smooth surface transition across the joints, thereby, reducing the possibility of cavitation damage occurring during high-flow releases.
